**Flood Control Project Maintenance  
Levee Inspections**

**Fall 2015 Levee Maintenance Deficiency Summary Report**

***San Joaquin River Basin***

**Reclamation District No. 2064 River Junction**

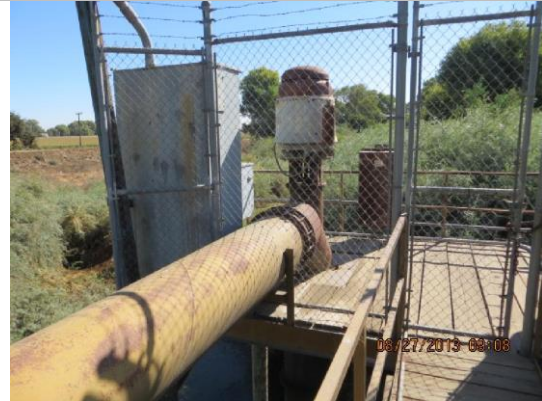
Photo 1 of 3 : UCIP\_FA\_2015\_1332.jpg

Inspector Comments: FS\_ID:18718  
DS\_ID:20512  
EP\_NO: 13907  
FS\_HLM: 0.077  
Repair Type: Non-Urgent  
Crossing Status: Found  
UCIP Comments: This pipe has less than 1-foot of cover.  
FIELD\_STRUCT\_DESC: 1 of 3: 24-inch stormdrain discharge pipe through the levee 2.0 feet below the crown (Permit No. 13907, 1985). Two 100-horsepower and one 75-horsepower pumps on landward toe of levee. Siphon breaker on WS shoulder.  
FS Date: 08/27/2013

Pump on wooden pier on LS toe.

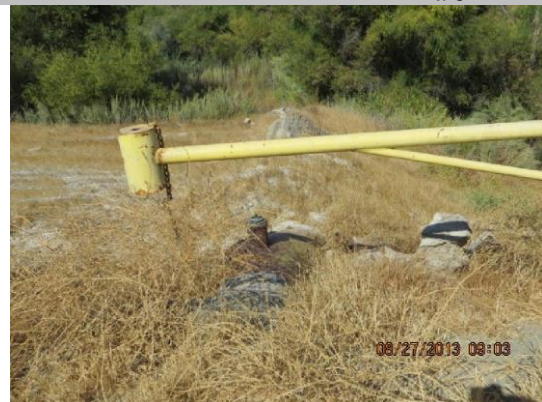
Photo 2 of 3 : UCIP\_FA\_2015\_1333.jpg

Pipe and siphon breaker visible on WS shoulder.

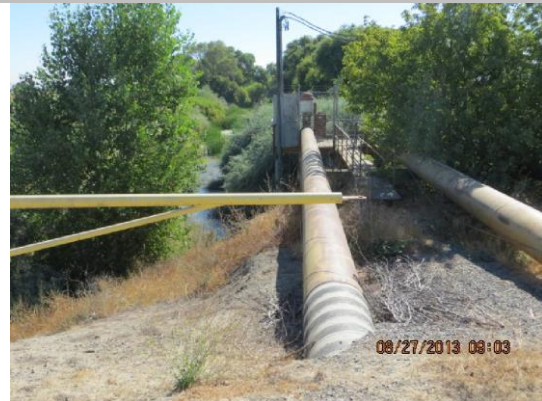
Photo 3 of 3 : UCIP\_FA\_2015\_1334.jpg

Steel storm drain pipe with pump on pier in background.

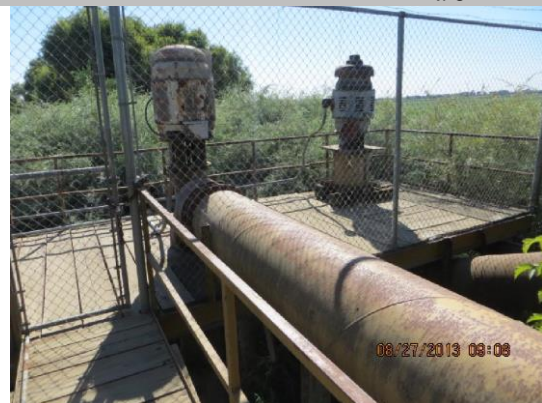
Photo 1 of 3 : UCIP\_FA\_2015\_2252.jpg

LM Start	0.06	Rating **	M	Issue No.	29
LM End	0.06	Issue Type +	En	Location *	LS
Category	Supplemental			GPS Latitude/Longitude	
				Start	End
Item	DWR UCIP Field Study			37.709698 °	37.709698 °
				-121.267536 °	-121.267536 °
DWR ID					
Action/Comments					
Inspector Comments: FS_ID:22729 DS_ID:20527 EP_NO: 13907 FS_HLM: 0.079 Repair Type: Non-Urgent Crossing Status: Found UCIP Comments: This pipe has less than 1-foot of cover. FIELD_STRUCT_DESC: 2 of 3: 24-inch steel stormdrain discharge pipe through the levee 2.0 feet below the crown (Permit No. 13907, 1985). Two 100-horsepower and one 75-horsepower pumps on pier at landward toe of levee. Siphon breaker on WS shoulder. FS Date: 08/27/2013

Pump on wooden pier at LS toe.

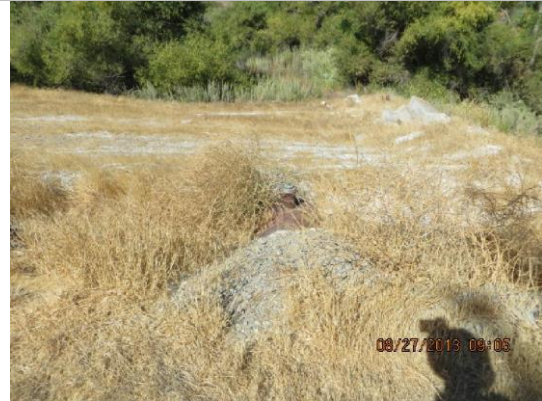
Photo 2 of 3 : UCIP\_FA\_2015\_2253.jpg

Pipe and siphon breaker on WS shoulder.

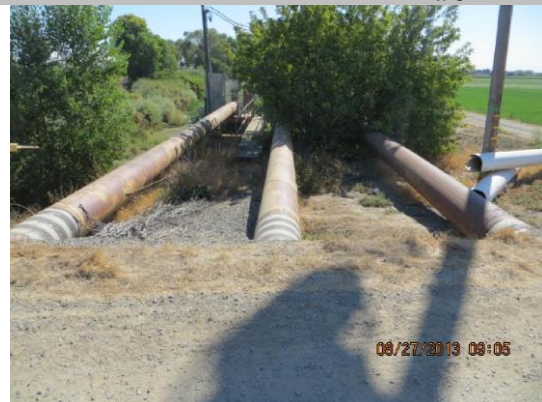
Photo 3 of 3 : UCIP\_FA\_2015\_2254.jpg

Pipe visible on LS.

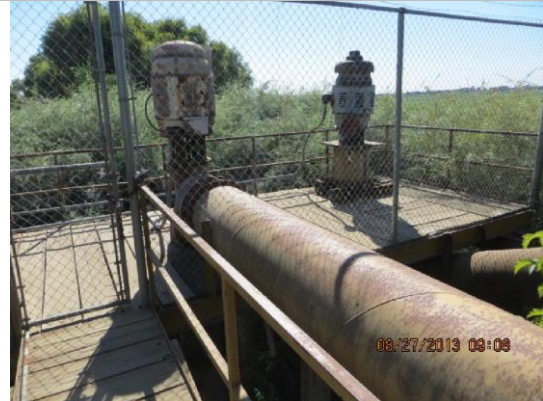
Photo 1 of 3 : UCIP\_FA\_2015\_1335.jpg

LM Start	0.06	Rating **	M	Issue No.	30
LM End	0.06	Issue Type +	En	Location *	LS
Category	Supplemental			GPS Latitude/Longitude	
				Start	End
Item	DWR UCIP Field Study			37.709672 °	37.709672 °
				-121.267532 °	-121.267532 °
DWR ID					
Action/Comments					
Inspector Comments: FS_ID:18720					
DS_ID:20528					
EP_NO: 13907					
FS_HLM: 0.08					
Repair Type: Non-Urgent					
Crossing Status: Found

Pump on pier on LS.

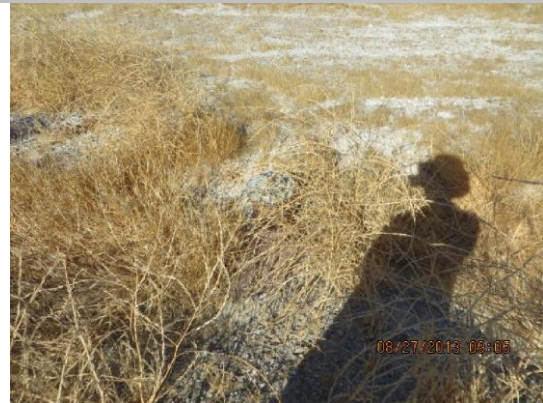
Photo 2 of 3 : UCIP\_FA\_2015\_1336.jpg

Siphon breaker visible on WS shoulder.

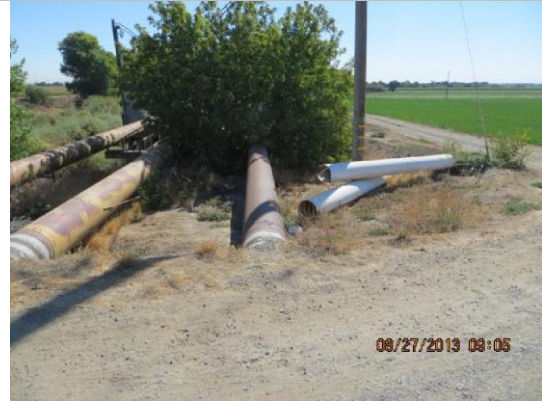
Photo 3 of 3 : UCIP\_FA\_2015\_1337.jpg

Steel pipe visible on LS.

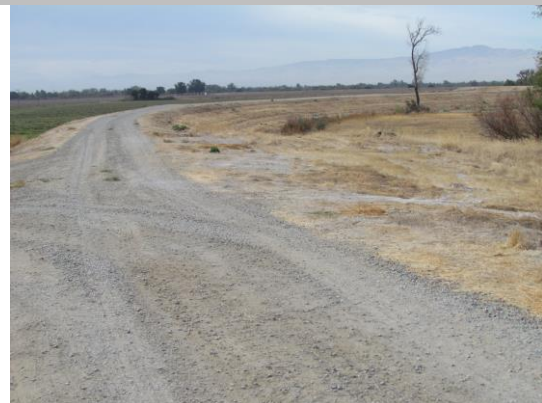
Photo 1 of 1 : FA\_2015\_RD2064\_313\_22\_20151001\_00009.jpg

LM Start	0.07	Rating **	A	Issue No.	21
LM End	1.49	Issue Type +	Ma	Location *	LS
Category	Earthen Levee			GPS Latitude/Longitude	
				Start	End
Item	Vegetation			37.709545 °	37.691882 °
				-121.267527 °	-121.269553 °
DWR ID	DWR_RD2064_01_f_2015_21				
Action/Comments					
Control annual grass and weeds on the levee slopes and easements.

Looking downstream from levee mile 0.07 district has mowed the slope to levee mile 1.49.

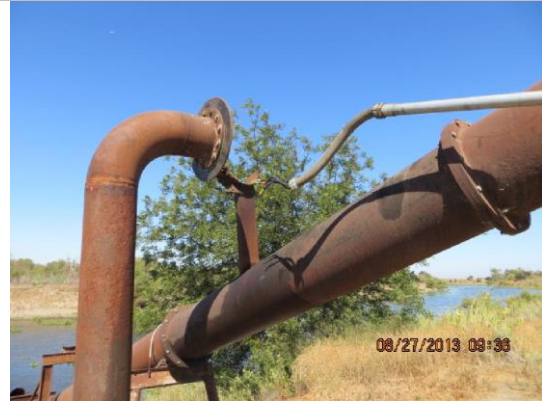
Photo 1 of 3 : UCIP\_FA\_2015\_1579.jpg

Inspector Comments: FS\_ID:40792  
 DS\_ID:20533  
 EP\_NO: N/A  
 FS\_HLM: 1.276  
 Repair Type: Non-Urgent  
 Crossing Status: Found  
 UCIP Comments: Pump and slant pipe missing from structure on WS slope.  
 FIELD\_STRUCT\_DESC: 12-inch steel concrete encased irrigation pipe through the levee 13.0 feet below the crown, slant pump on the WS toe. Slide gate in 36-inch CMP riser on the WS shoulder. 6'X6' concrete distribution box and filter plant on LS toe. 2-inch galvanized iron electrical conduit at same location. Originally included in the 1968 O&M manual.  
 FS Date: 08/27/2013

Pump and slant pipe missing from structure on WS slope.

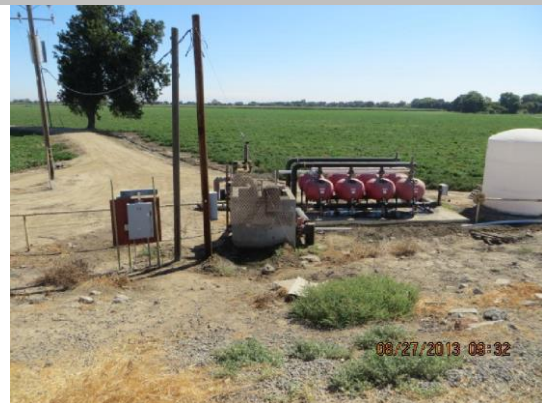
Photo 2 of 3 : UCIP\_FA\_2015\_1580.jpg

Concrete distribution box and filter plant on LS toe.

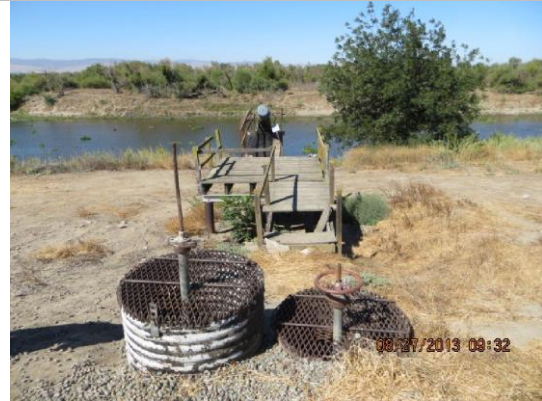
Photo 3 of 3 : UCIP\_FA\_2015\_1581.jpg

Slide gate in CMP riser on WS shoulder.

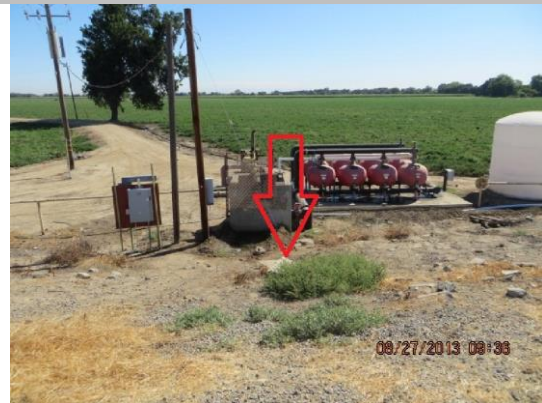
Photo 1 of 3 : UCIP\_FA\_2015\_2255.jpg

LM Start	1.23	Rating **	U	Issue No.	32
LM End	1.23	Issue Type +	En	Location *	WS
Category	Supplemental			GPS Latitude/Longitude	
				Start	End
Item	DWR UCIP Field Study			37.695506 °	37.695506 °
				-121.269995 °	-121.269995 °
DWR ID					
Action/Comments					
Inspector Comments: FS_ID:42940					
DS_ID:20524					
EP_NO: 3739					
FS_HLM: 1.277					
Repair Type: Urgent					
Crossing Status: Found					
UCIP Comments: Some leakage at connection between pipe and					
distro box on LS toe. This may indicate internal failure of pipe.					
FIELD_STRUCT_DESC: 16-inch steel irrigation pipe through the levee					
10.75-feet below the crown. Slant pump on WS toe. Slide gate in 36-					
inch CMP riser on WS shoulder. 6'X6' concrete distribution box and					
filter plant on LS toe. 2-inch galvanized iron electrical conduit at same					
location.					
FS Date: 08/27/2013

Leakage along pipe alignment on LS toe.

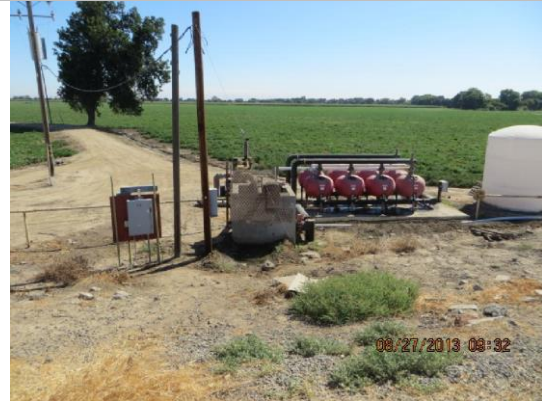
Photo 2 of 3 : UCIP\_FA\_2015\_2256.jpg

Concrete distribution box on LS toe with filter plant.

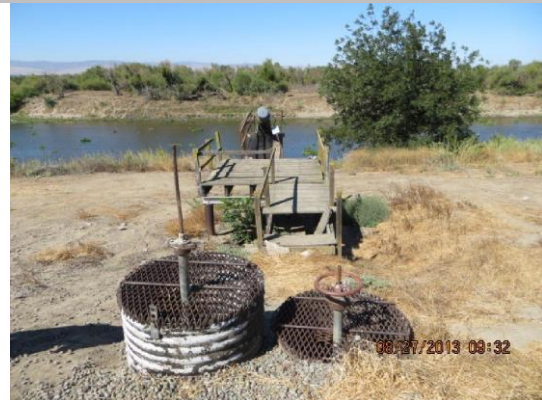
Photo 3 of 3 : UCIP\_FA\_2015\_2257.jpg

Slant pump on WS toe. Slide gate in 36-inch CMP riser on WS shoulder.

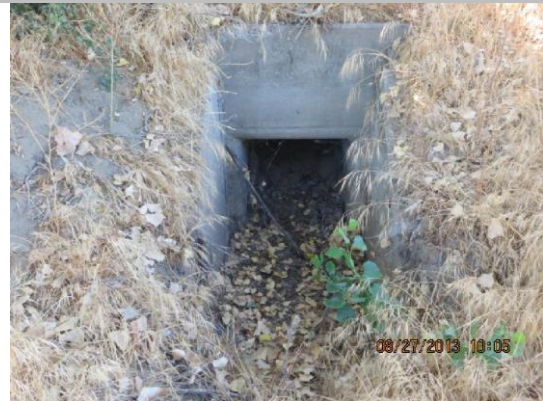
Photo 1 of 3 : UCIP\_FA\_2015\_1582.jpg

Concrete U-shaped headwall on LS toe.

Inspector Comments: FS\_ID:18763  
 DS\_ID:20515  
 EP\_NO: N/A  
 FS\_HLM: 1.997  
 Repair Type: Non-Urgent  
 Crossing Status: Found  
 UCIP Comments: Culvert filled nearly to the top with soil.  
 FIELD\_STRUCT\_DESC: 30-inch square reinforced concrete stormdrain box culvert through the levee 14.7-feet below the crown. Slide gate in concrete riser unit on the waterward slope. Concrete "U" shaped headwalls on both ends. Flap gate on the waterward end. Originally included in the 1968 O&M manual.  
 FS Date: 08/27/2013

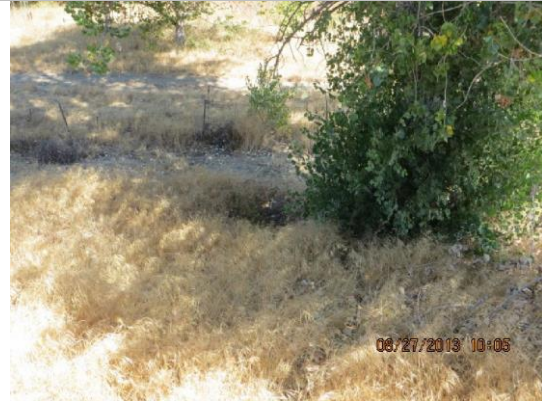
Photo 2 of 3 : UCIP\_FA\_2015\_1583.jpg

Concrete U-shaped headwall on LS toe.

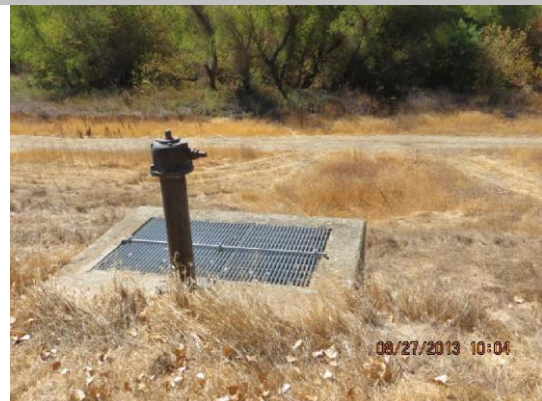
Photo 3 of 3 : UCIP\_FA\_2015\_1584.jpg

Slide gate in Concrete riser on WS shoulder.

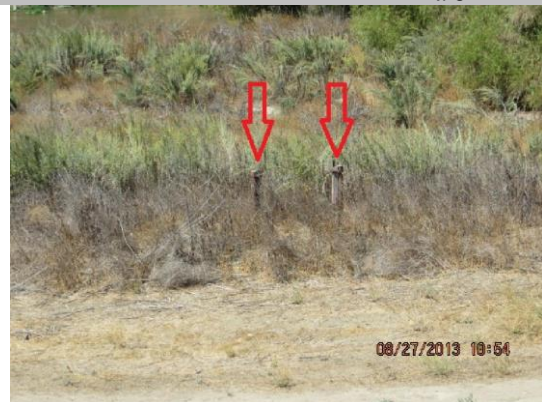
Photo 1 of 1 : UCIP\_FA\_2015\_2258.jpg

LM Start	3.46	Rating **	M	Issue No.	34
LM End	3.46	Issue Type +	En	Location *	WS
Category	Supplemental			GPS Latitude/Longitude	
				Start	End
Item	DWR UCIP Field Study			37.676751 °	37.676751 °
				-121.264193 °	-121.264193 °
DWR ID					
Action/Comments					
Inspector Comments: FS_ID:22731 DS_ID:20517 EP_NO: N/A FS_HLM: 3.553 Repair Type: Non-Urgent Crossing Status: Indicator Found UCIP Comments: Neet to verify status of pipeline. FIELD_STRUCT_DESC: Underground gas line crossing; depth through the levee and size unknown. Found possible sign posts on WS toe. FS Date: 08/27/2013

Possible sign posts on WS toe.

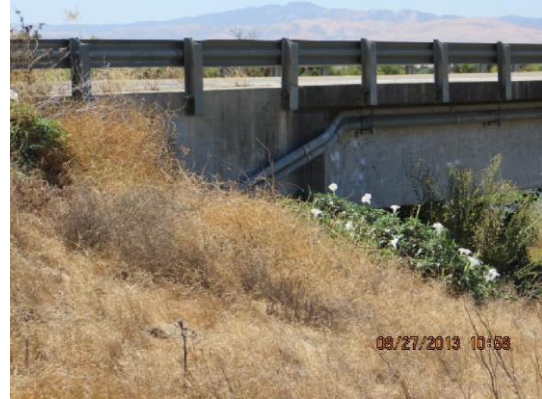
Photo 1 of 1 : UCIP\_FA\_2015\_1698.jpg

LM Start	3.49	Rating **	M	Issue No.	35
LM End	3.49	Issue Type +	En	Location *	WS
Category	Supplemental			GPS Latitude/Longitude	
				Start	End
Item	DWR UCIP Field Study			37.676276 °	37.676276 °
				-121.264104 °	-121.264104 °
DWR ID					
Action/Comments					
Inspector Comments: FS_ID:22790					
DS_ID:24060					
EP_NO: N/A					
FS_HLM: 3.588					
Repair Type: Non-Urgent					
Crossing Status: Found					
UCIP Comments: Unable to identify purpose or permit for this crossing.					
FIELD_STRUCT_DESC: 2 of 2: 4-inch galvanized iron conduit through the levee at unknown depth below the crown. Visible on downstream side of the bridge. 3.5-foot by 6-foot steel vault on crown.					
FS Date: 08/27/2013

Lower conduit visible on DS side of bridge at WS slope.

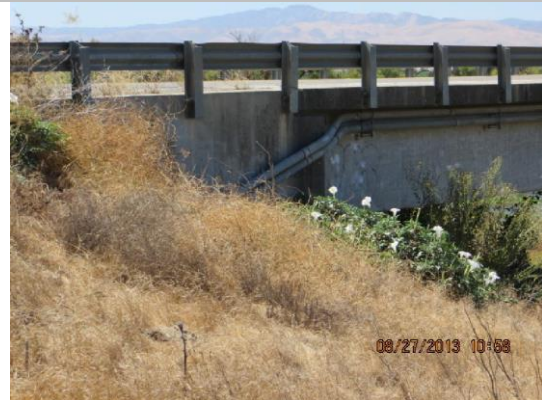
Photo 1 of 1 : UCIP\_FA\_2015\_2380.jpg

LM Start	3.49	Rating **	M	Issue No.	36
LM End	3.49	Issue Type +	En	Location *	WS
Category	Supplemental			GPS Latitude/Longitude	
				Start	End
Item	DWR UCIP Field Study			37.676276 °	37.676276 °
				-121.264104 °	-121.264104 °
DWR ID					
Action/Comments					
Inspector Comments: FS_ID:22085 DS_ID:24059 EP_NO: N/A FS_HLM: 3.588 Repair Type: Non-Urgent Crossing Status: Found UCIP Comments: Unable to identify purpose or permit for this crossing. FIELD_STRUCT_DESC: 1 of 2: 4-inch galvanized iron conduit through the levee at unknown depth below the crown. Visible on downstream side of the bridge. 3.5-foot by 6-foot steel vault on crown. FS Date: 08/27/2013

Upper conduit visible on DS side of bridge.

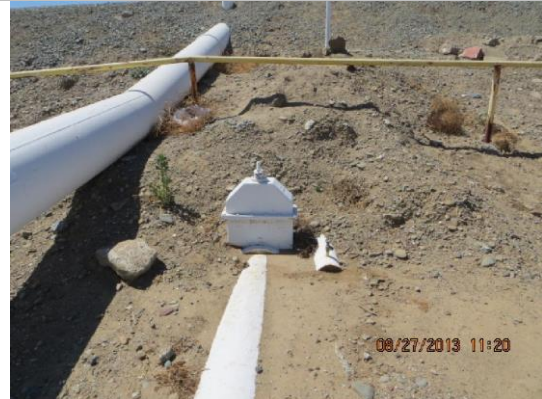
Photo 1 of 3 : UCIP\_FA\_2015\_1666.jpg

Inspector Comments: FS\_ID:19044  
 DS\_ID:20519  
 EP\_NO: 6450  
 FS\_HLM: 3.673  
 Repair Type: Non-Urgent  
 Crossing Status: Found  
 UCIP Comments: Appears abandoned and if so should be done so properly.  
 FIELD\_STRUCT\_DESC: 18-inch steel discharge pipe through the levee 2-feet below the crown. Crown roadway padded over the pipe. Pipe exposed on both slopes. Gate valve on the LS toe. Pump missing from sump with sheet pile siding in ditch on the landside. Siphon breaker on the waterward side (Permit No. 6450, 1969).  
 FS Date: 08/27/2013

Gate valve on LS toe.

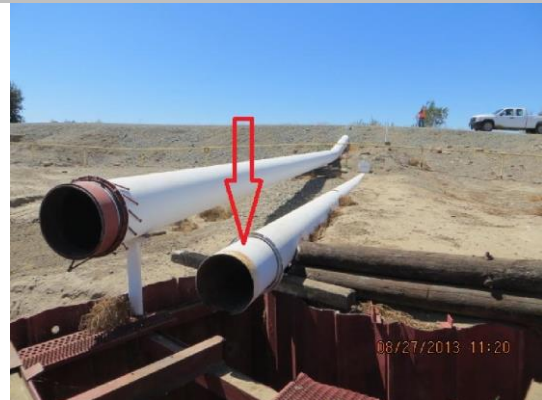
Photo 2 of 3 : UCIP\_FA\_2015\_1667.jpg

Pipe visible at sump off LS toe. No pump or appurtenances.

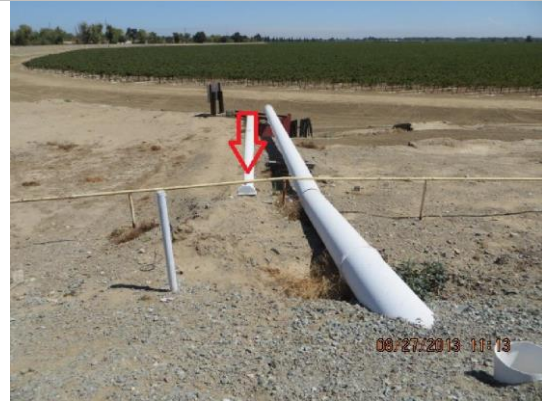
Photo 3 of 3 : UCIP\_FA\_2015\_1668.jpg

Pipe and gate valve on LS toe.

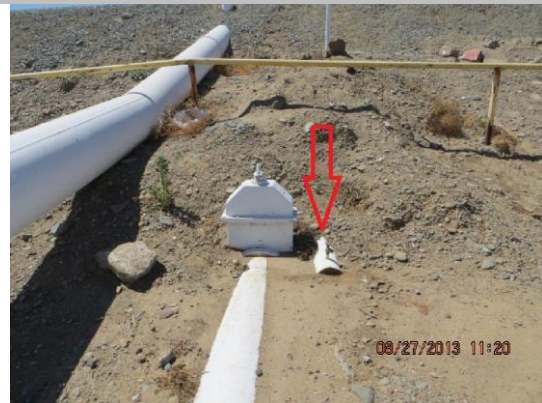
Photo 1 of 2 : UCIP\_FA\_2015\_2259.jpg

LM Start	3.57	Rating **	M	Issue No.	38
LM End	3.57	Issue Type +	En	Location *	WS
Category	Supplemental			GPS Latitude/Longitude	
				Start	End
Item	DWR UCIP Field Study			37.675266 °	37.675266 °
				-121.263421 °	-121.263421 °
DWR ID					
Action/Comments					
Inspector Comments: FS_ID:22732 DS_ID:20525 EP_NO: N/A FS_HLM: 3.671 Repair Type: Non-Urgent Crossing Status: Found UCIP Comments: Need to determine if pipe was actually removed from levee. FIELD_STRUCT_DESC: 12-inch steel stormdrain pipe through the levee at unknown depth below the crown. Steel plate welded over LS end at LS toe. Permit No. 6450, states it was removed in 1973, but it remains visible on the LS toe. Originally included in the 1968 O&M manual. FS Date: 08/27/2013

Pipe with welded steel plate over LS end at LS toe.

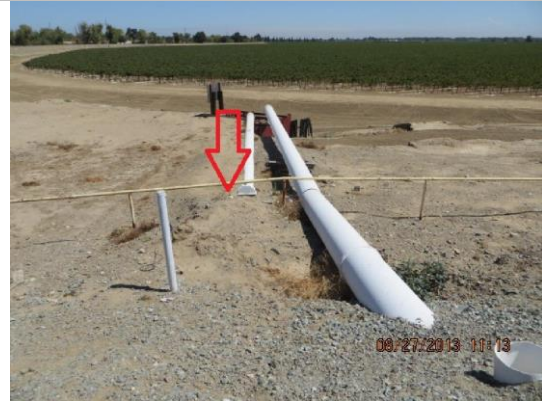
Photo 2 of 2 : UCIP\_FA\_2015\_2260.jpg

Pipe visible on LS toe.

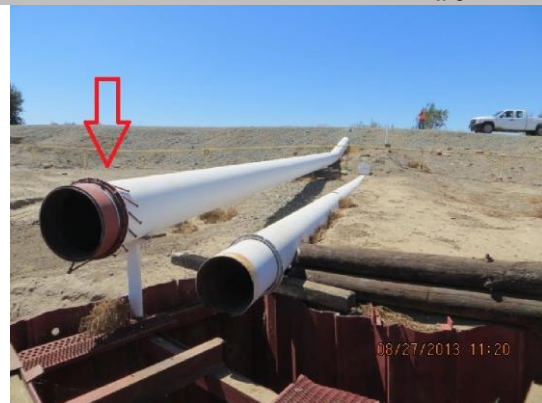
Photo 1 of 3 : UCIP\_FA\_2015\_2261.jpg

Pipe open at pump sump off LS toe.

Action/Comments					
Inspector Comments: FS_ID:22733 DS_ID:20522 EP_NO: 13609 FS_HLM: 3.673 Repair Type: Non-Urgent Crossing Status: Found UCIP Comments: Appears abandoned and should be done so properly. Pipe was to be removed in 1984. FIELD_STRUCT_DESC: 1 of 2: 24-inch steel discharge pipe through the levee 2-feet below the crown (Permit No. 13609, 1983). Approx. 420 feet upstream of Durham Ferry-Airport Way Road. FS Date: 08/27/2013

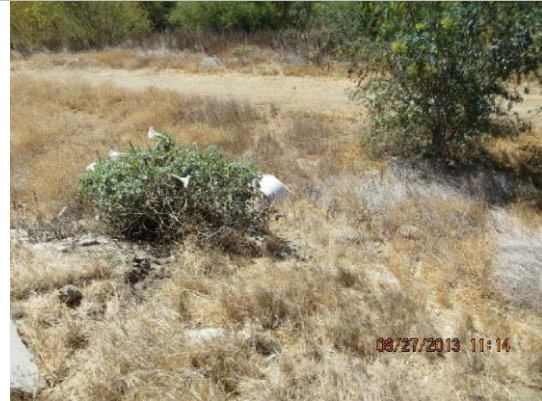
Photo 2 of 3 : UCIP\_FA\_2015\_2262.jpg

Pipe visible on WS slope.

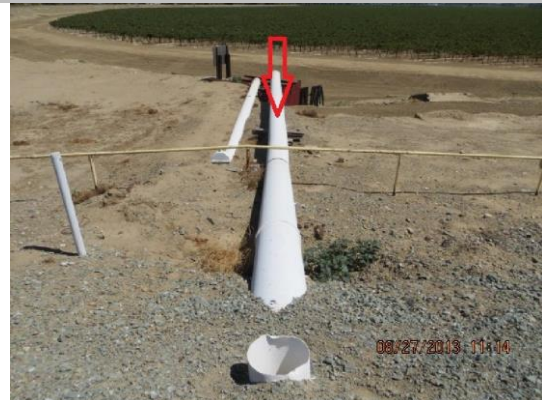
Photo 3 of 3 : UCIP\_FA\_2015\_2263.jpg

Pipe and vent visible on LS slope.

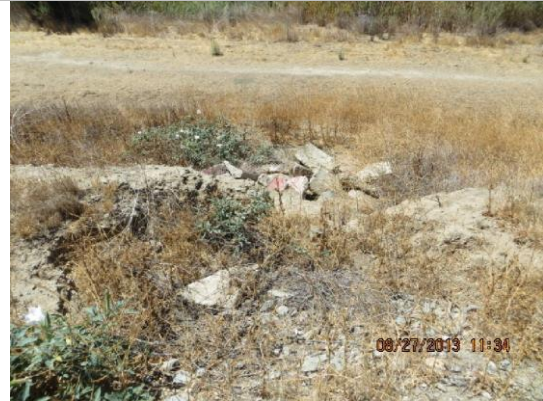
Photo 1 of 2 : UCIP\_FA\_2015\_1501.jpg

LM Start	3.60	Rating **	M	Issue No.	40
LM End	3.60	Issue Type +	En	Location *	WS
Category	Supplemental			GPS Latitude/Longitude	
				Start	End
Item	DWR UCIP Field Study			37.675005 °	37.675005 °
				-121.263103 °	-121.263103 °
DWR ID					
Action/Comments					
Inspector Comments: FS_ID:19046					
DS_ID:20534					
EP_NO: 13609					
FS_HLM: 3.697					
Repair Type: Non-Urgent					
Crossing Status: Indicator Found

Concrete rubble on WS slope possible indicator of abandoned pipe location.

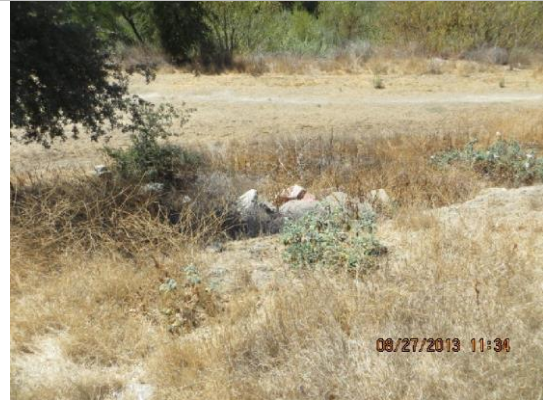
Photo 2 of 2 : UCIP\_FA\_2015\_1502.jpg

Concrete rubble on WS slope possible indicator of abandoned pipe location.

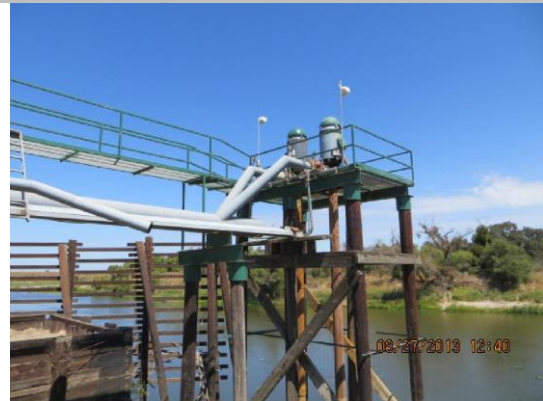
Photo 1 of 2 : UCIP\_FA\_2015\_1505.jpg

LM Start	4.72	Rating **	M	Issue No.	41
LM End	4.72	Issue Type +	En	Location *	LS
Category	Supplemental			GPS Latitude/Longitude	
				Start	End
Item	DWR UCIP Field Study			37.670161 °	37.670161 °
				-121.246973 °	-121.246973 °
DWR ID					
Action/Comments					
Inspector Comments: FS_ID:19064 DS_ID:20530 EP_NO: 3359 FS_HLM: 4.843 Repair Type: Non-Urgent Crossing Status: Indicator Found UCIP Comments: Pipe not found. Need to determine disposition of pipe as all other appurtenances remain. FIELD_STRUCT_DESC: 2 of 2: 18-inch pipe through levee 3.5 feet below the crown (Permit No. 3359, 1961). Pump mounted on pipe structure in the river; protective fender in the stream, wooden walkway to the pump structure. Siphon breaker on the landward side. Originally included in the 1968 O&M manual. FS Date: 08/27/2013

Pump platform and fender visible on WS toe.

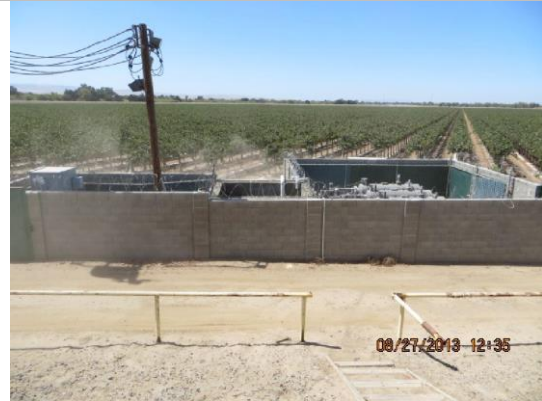
Photo 2 of 2 : UCIP\_FA\_2015\_1506.jpg

Concrete distribution box in center of structure on LS toe.

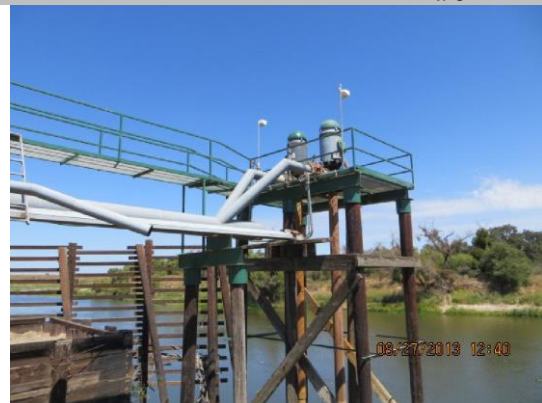
Photo 1 of 2 : UCIP\_FA\_2015\_1503.jpg

LM Start	4.72	Rating **	M	Issue No.	42
LM End	4.72	Issue Type +	En	Location *	LS
Category	Supplemental			GPS Latitude/Longitude	
				Start	End
Item	DWR UCIP Field Study			37.670161 °	37.670161 °
				-121.246973 °	-121.246973 °
DWR ID					
Action/Comments					
Inspector Comments: FS_ID:19063 DS_ID:20520 EP_NO: 3359 FS_HLM: 4.843 Repair Type: Non-Urgent Crossing Status: Indicator Found UCIP Comments: Pipe not found. Need to determine disposition of pipe as all other appurtenances remain. FIELD_STRUCT_DESC: 1 of 2: 24-inch pipe through the levee 3.5 feet below the crown (Permit No. 3359, 1961). Pump mounted on pipe structure in the river; protective fender in the stream, wooden walkway to the pump structure. Siphon breaker on the landward side. Originally included in the 1968 O&M manual. FS Date: 08/27/2013

Pump platform, walkway, and fender remain in stream. No 24-1inch pipe found.

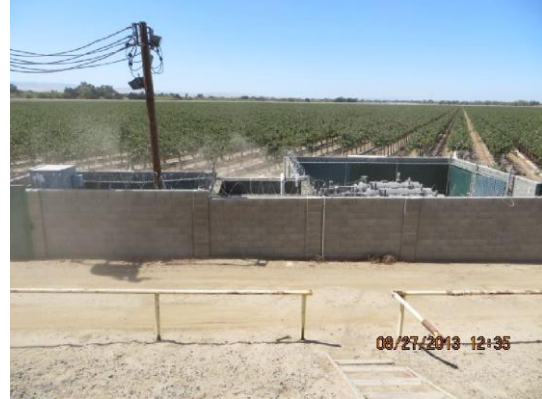
Photo 2 of 2 : UCIP\_FA\_2015\_1504.jpg

Concrete distribution box remains in center of structure on LS toe.

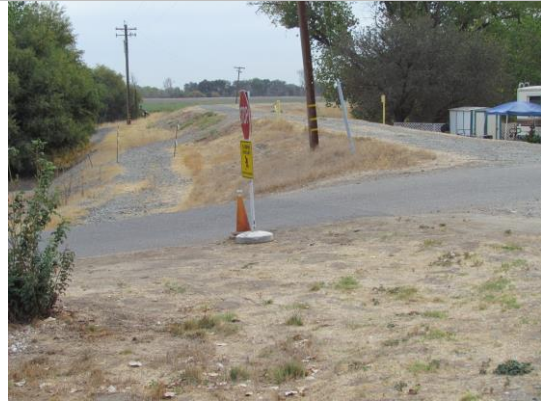
Photo 1 of 1 : FA\_2015\_RD2064\_314\_17\_20151006\_00013.jpg

RD 2064 Looking downstream from levee mile 0.05 landside slope.

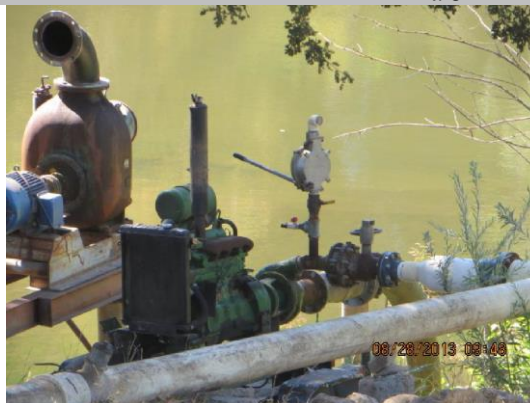
Photo 1 of 3 : UCIP\_FA\_2015\_2416.jpg

Portable pump on WS berm.

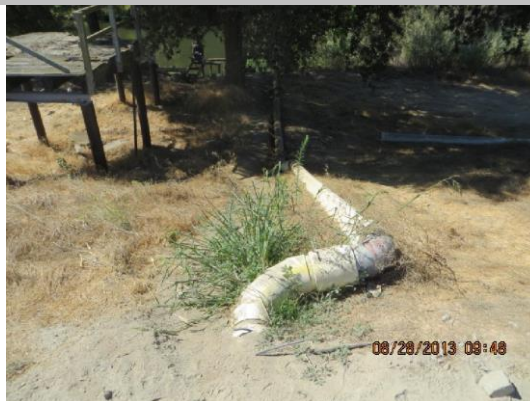
Photo 2 of 3 : UCIP\_FA\_2015\_2417.jpg

Pipe visible on WS shoulder/slope.

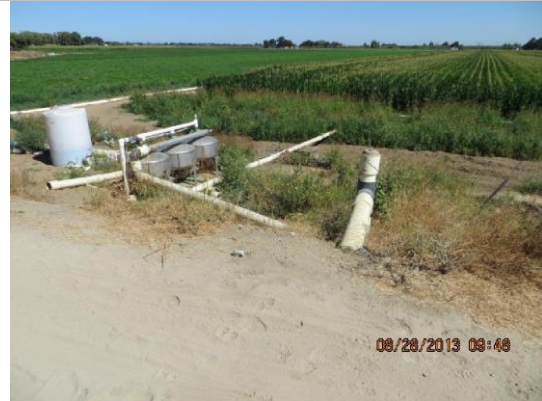
Photo 3 of 3 : UCIP\_FA\_2015\_2418.jpg

Pipe, vent, and filter plant on LS shoulder and LS toe.

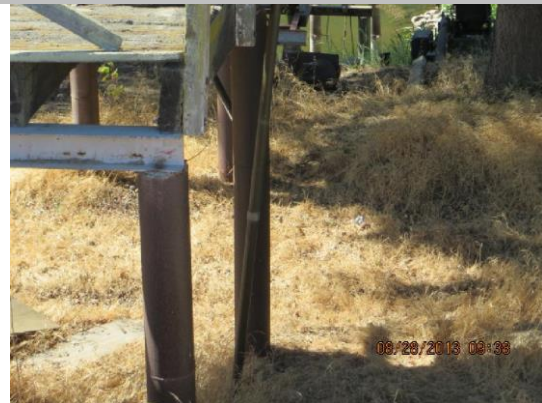
Photo 1 of 3 : UCIP\_FA\_2015\_1553.jpg

2-inch galvanized iron electrical conduit at same location.

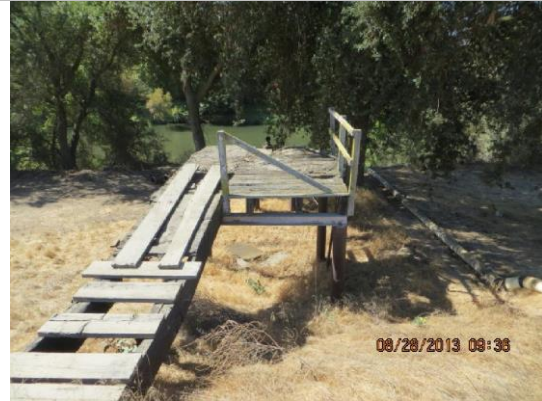
Photo 2 of 3 : UCIP\_FA\_2015\_1554.jpg

Deteriated wooded pump platform on WS shoulder.

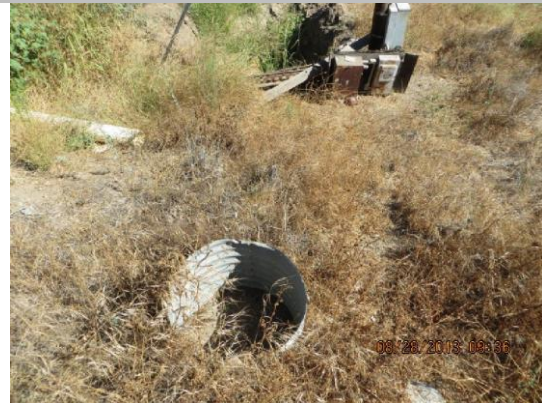
Photo 3 of 3 : UCIP\_FA\_2015\_1555.jpg

Siphon breaker in 24-inch CMP riser on LS shoulder.

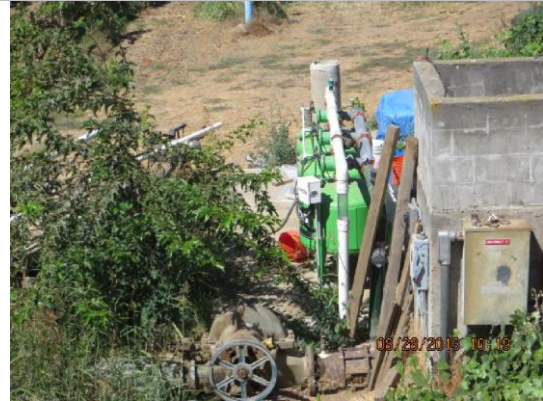
Photo 1 of 3 : UCIP\_FA\_2015\_2419.jpg

Filterplant visible on LS toe.

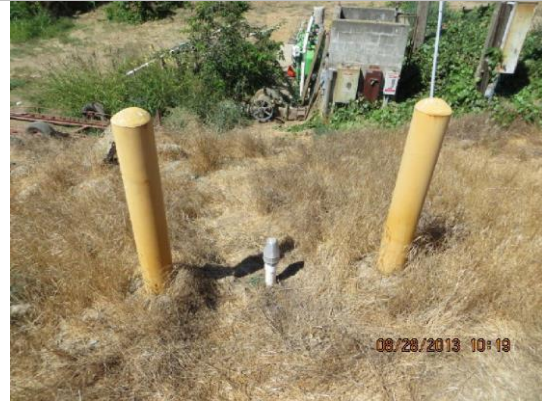
Photo 2 of 3 : UCIP\_FA\_2015\_2420.jpg

Vent on LS shoulder.

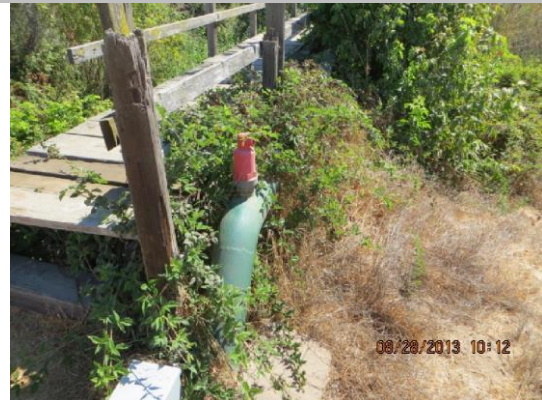
Photo 3 of 3 : UCIP\_FA\_2015\_2421.jpg

Pipe and vent visible on WS shoulder at wooden walkway.

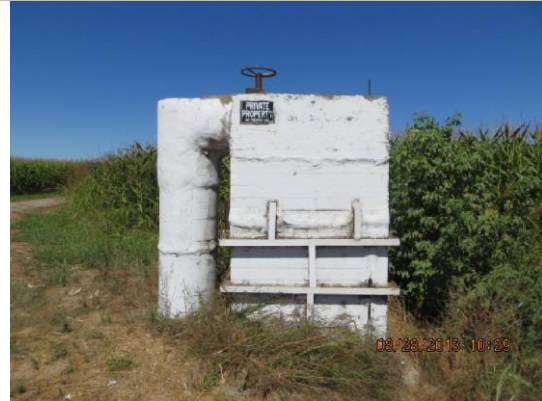
Photo 1 of 3 : UCIP\_FA\_2015\_1575.jpg

Concrete riser in field north of levee likely outlet for cox culvert.

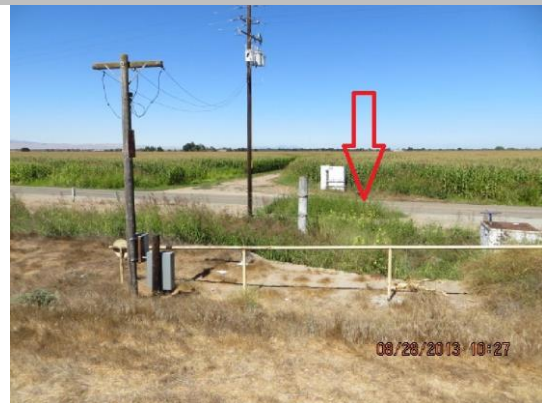
Photo 2 of 3 : UCIP\_FA\_2015\_1576.jpg

Wet area next to roadway off LS toe may indicate a leak. Power pole and meter on LS toe.

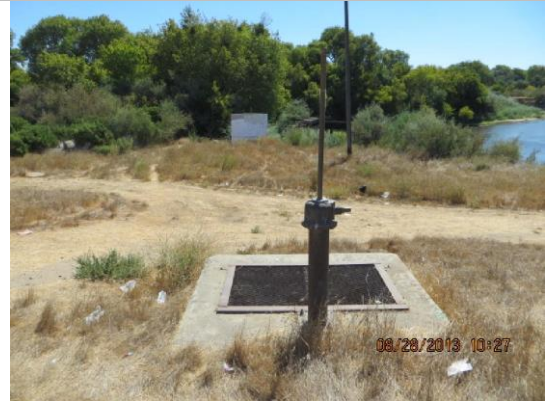
Photo 3 of 3 : UCIP\_FA\_2015\_1577.jpg

Gate valve on WS shoulder. Pump next to concrete riser in background.

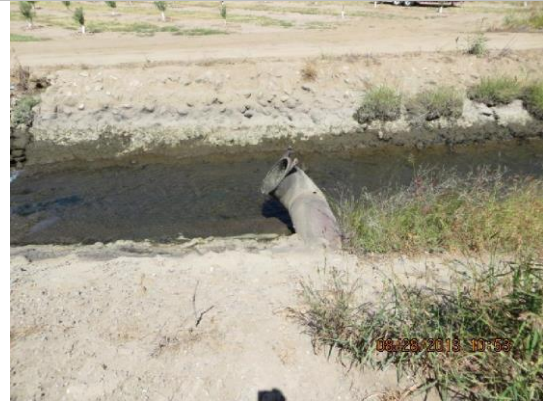
Photo 1 of 3 : UCIP\_FA\_2015\_1587.jpg

Pipe with missing flapgate on LS at concrete ditch.

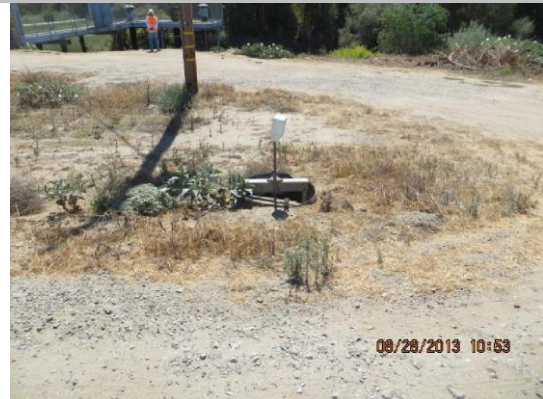
Photo 2 of 3 : UCIP\_FA\_2015\_1588.jpg

Slide gate in 36-inch CMP riser on WS slope.

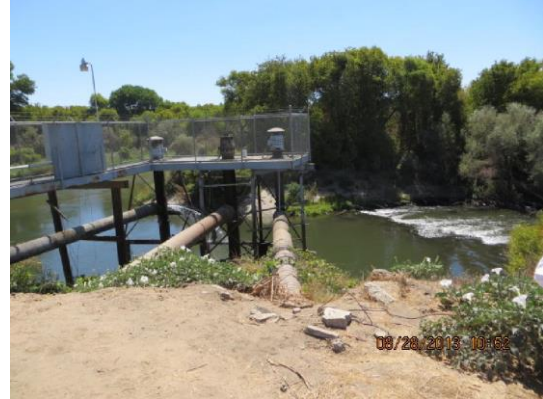
Photo 3 of 3 : UCIP\_FA\_2015\_1589.jpg

Pipe and pump visible on WS berm.

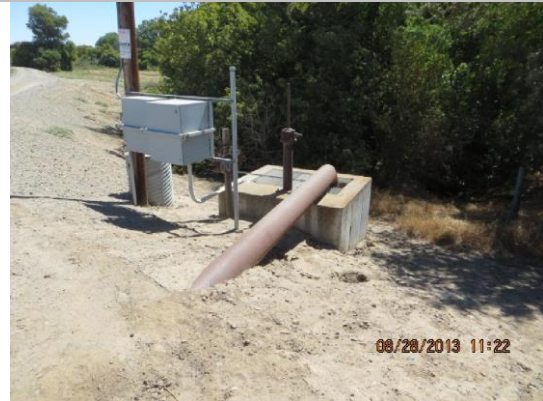
Photo 1 of 2 : UCIP\_FA\_2015\_2445.jpg

Pipe discharges into concrete riser on WS slope.

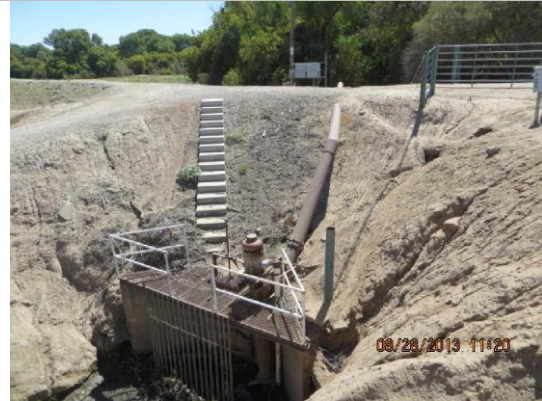
Photo 2 of 2 : UCIP\_FA\_2015\_2446.jpg

Pump for pipe on concrete headwall at LS toe.

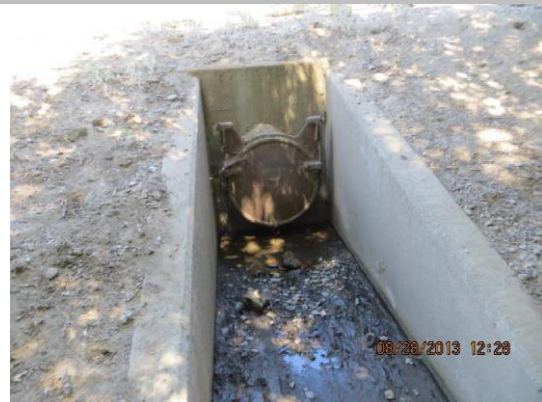
Photo 1 of 3 : UCIP\_FA\_2015\_2450.jpg

Evidence of discharge from PVC on WS toe.

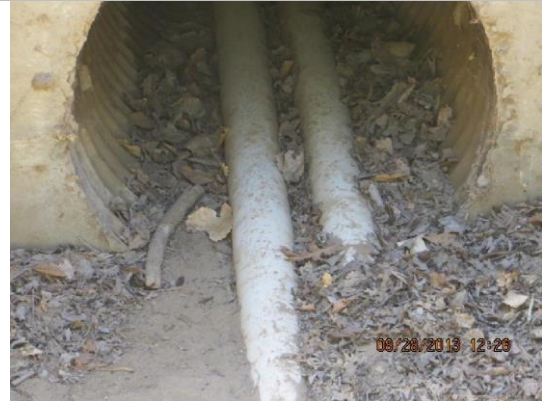
Photo 2 of 3 : UCIP\_FA\_2015\_2451.jpg

PVC conduit at left on LS toe.

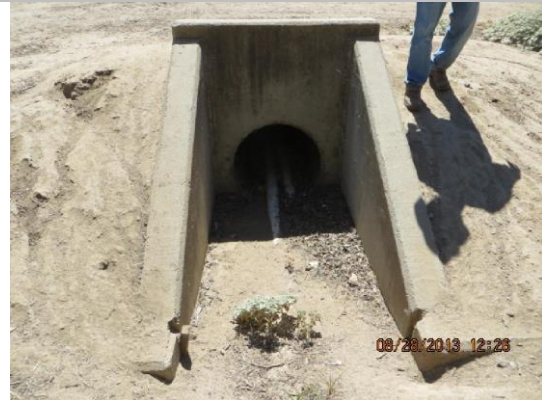
Photo 3 of 3 : UCIP\_FA\_2015\_2452.jpg

PVC conduit at left on LS toe.

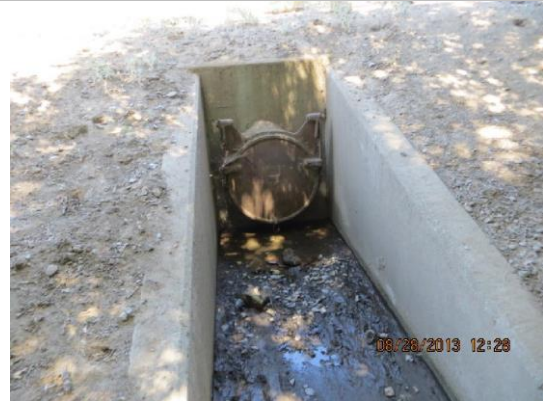
Photo 1 of 3 : UCIP\_FA\_2015\_2447.jpg

Evidence of discharge through PVC conduit on WS toe.

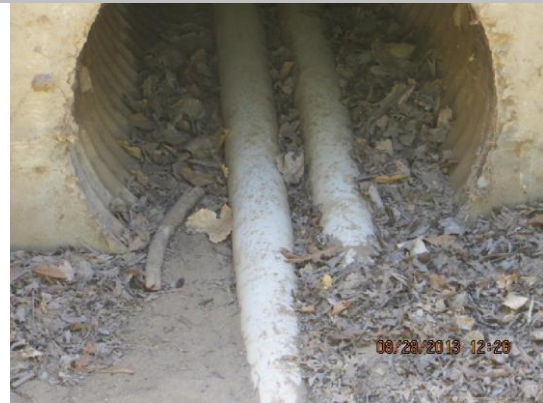
Photo 2 of 3 : UCIP\_FA\_2015\_2448.jpg

PVC pipe at right inside stormdrain on LS toe.

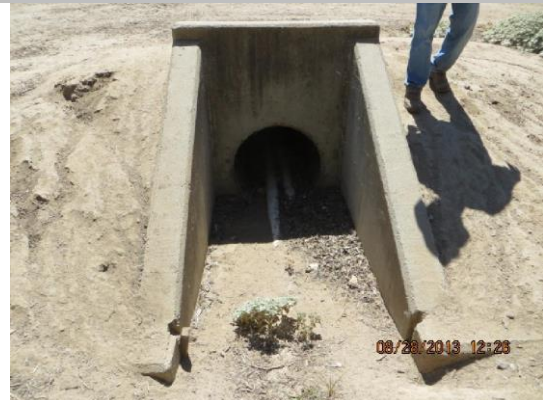
Photo 3 of 3 : UCIP\_FA\_2015\_2449.jpg

PVC pipe at right inside stormdrain on LS toe.

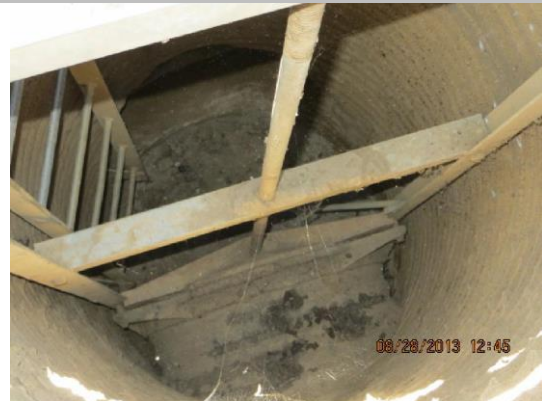
Photo 1 of 2 : UCIP\_FA\_2015\_1168.jpg

Pipe in CMP riser on WS slope.

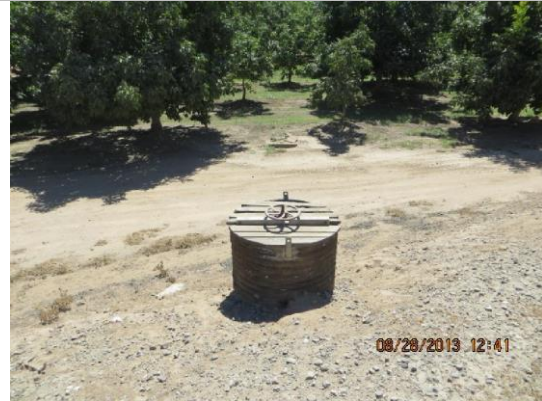
Photo 2 of 2 : UCIP\_FA\_2015\_1169.jpg

Slide gate in CMP riser on WS slope

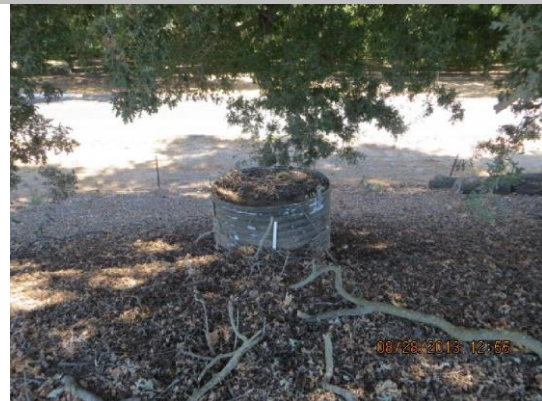
Photo 1 of 1 : UCIP\_FA\_2015\_1170.jpg

CMP riser for slide gate filled with soil.
